INSTALLATION RESTORATION PROGRAM

Records Search

8204th Field Training Site
Wisconsin Air National Guard
Volk Field Air National Guard Base

August 1984

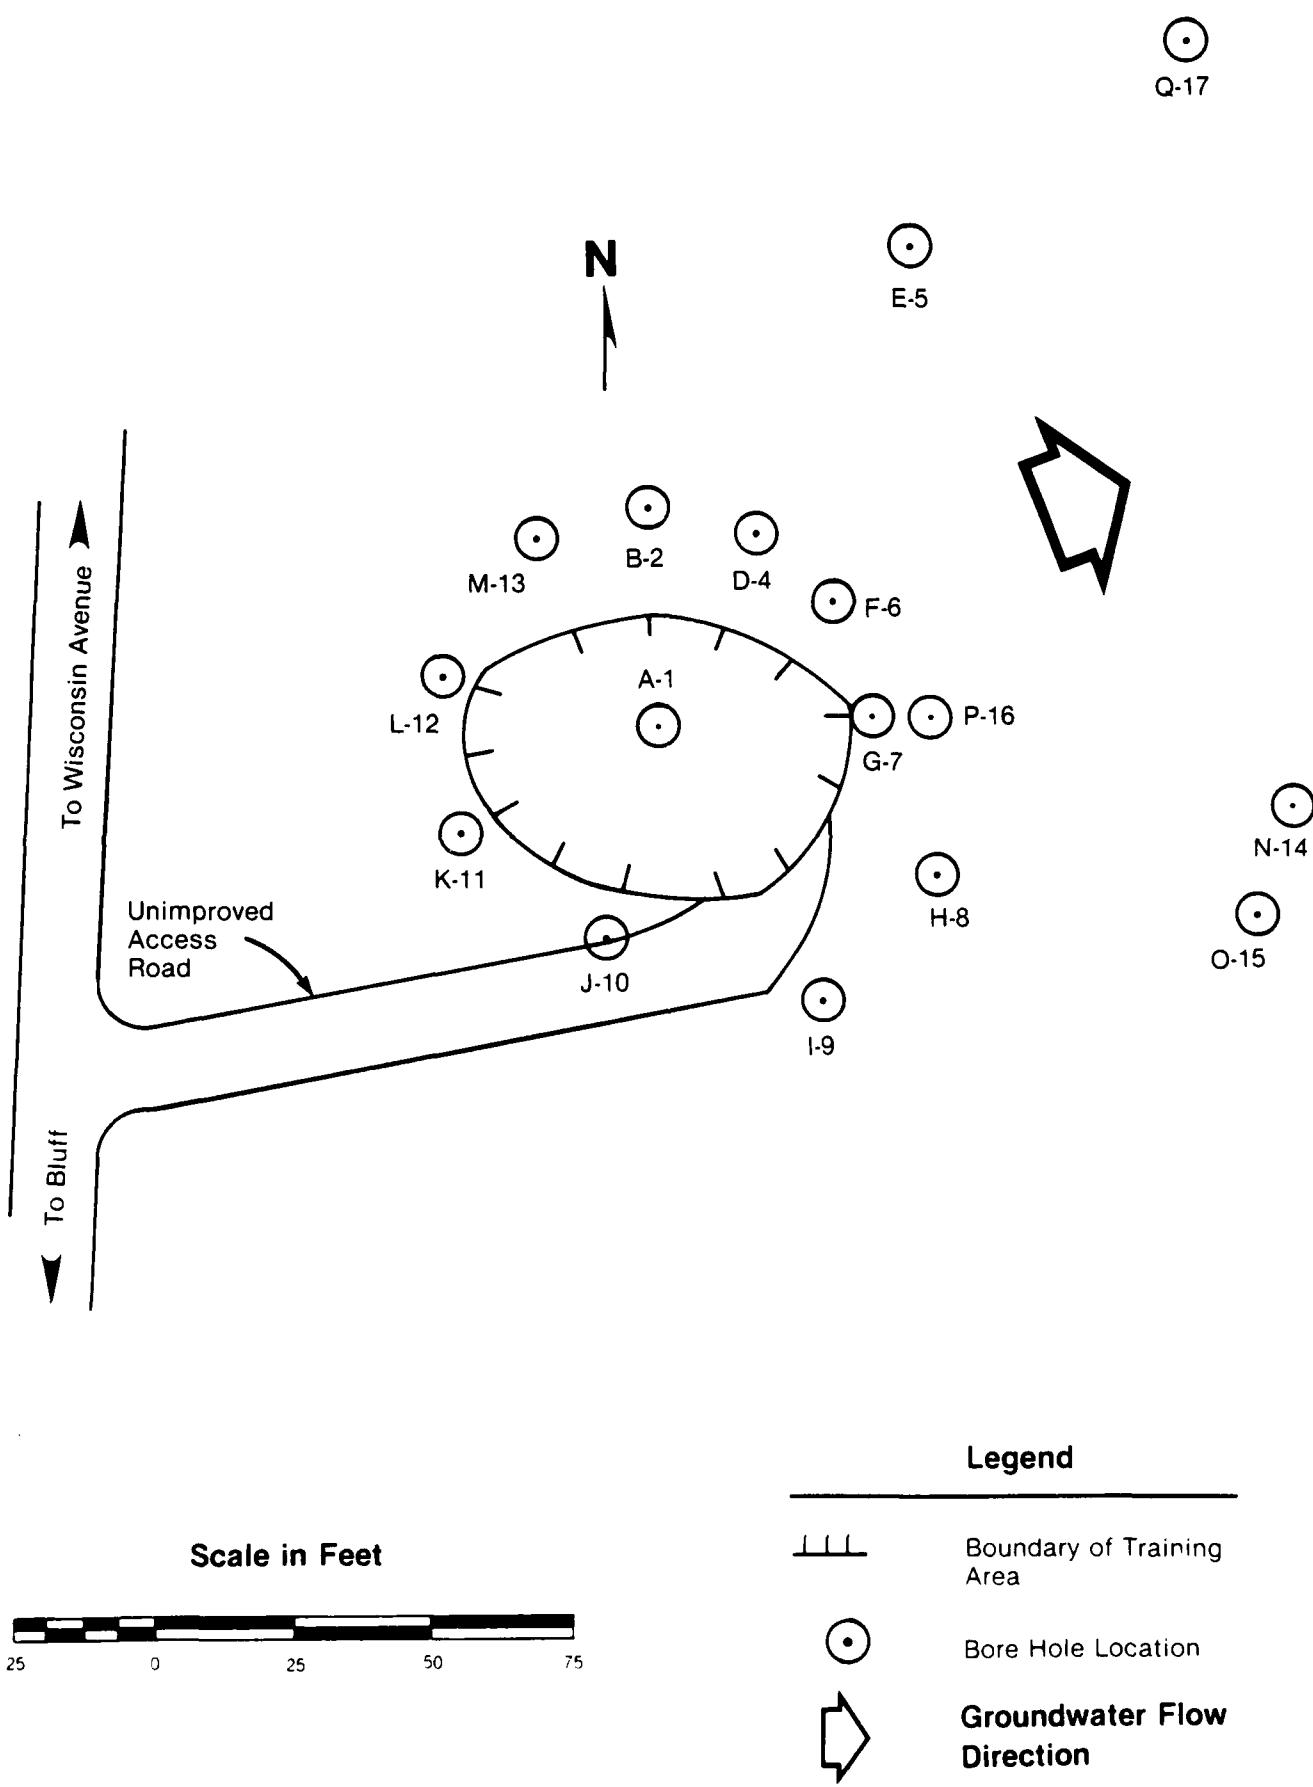
Figure 14.

Figure 14 is a plat of the Fire Department Training Area which illustrates the locations of the existing groundwater monitoring boreholes. The method of installation of these monitoring wells was to drill down to the depth of the water table and then install 4-inch diameter PVC casing equipped with 2-foot long screens at the bottom of the casing. The casing and attached screens were installed so that the top of the screened interval was at the same elevation as the water table observed during drilling. The average observed depth to the water table was approximately 13 feet. From these boreholes, a total of 15 water samples were collected and then submitted for analysis on July 20, 1981. Of these 15 samples, 12 were analyzed for purgeables by EPA Methods 601 and 602. EPA Method 601 analyzes for 28 different analytes and Method 602 analyzes for 3 different analytes. From the total of 31 different analytes for which analyses were performed, 6 analytes were detected. The concentrations of the detected analytes and the boreholes from which the corresponding water samples were collected are summarized in Table 4. These 6 detected analytes are chloroform, 1,1,1-trichloroethane, trichloroethylene, benzene, toluene, and ethyl benzene. The remaining 3 water samples, from the original total of 15, were screened for purgeables by EPA Method 624. None of the analytes specified in EPA Method 624 were detected in these three water samples, as indicated in Table 4.

only, due to the presence of unknown interferences within the samples. Additionally, some of the samples analyzed by EPA Methods 601 and 602 were observed to be biphasic, thus suggesting the presence of free hydrocarbons within the subsurface of the Fire Department Training Area.

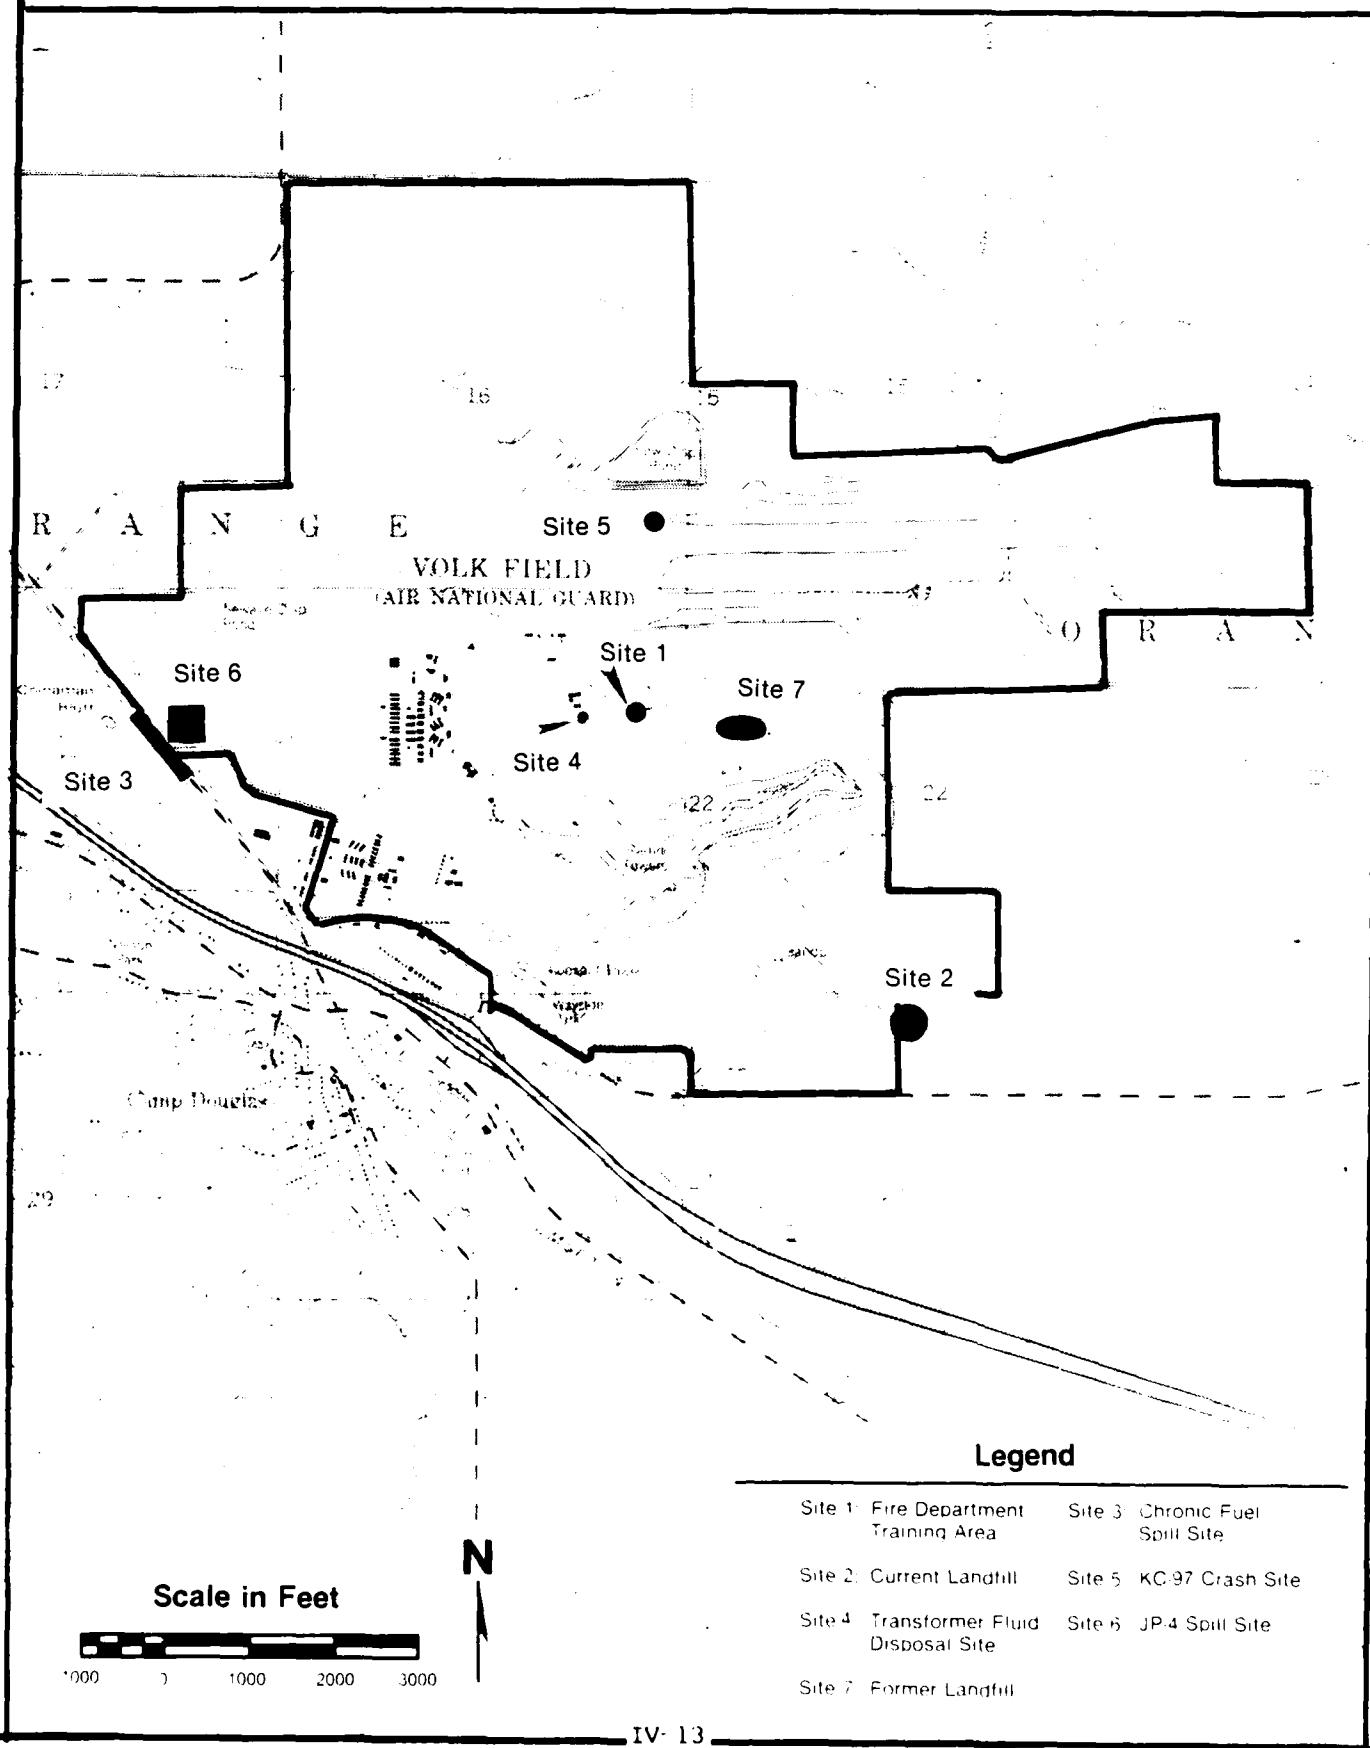
Figure 15a.

Location of the Rated Waste Disposal and Spill Sites at Volk Field.

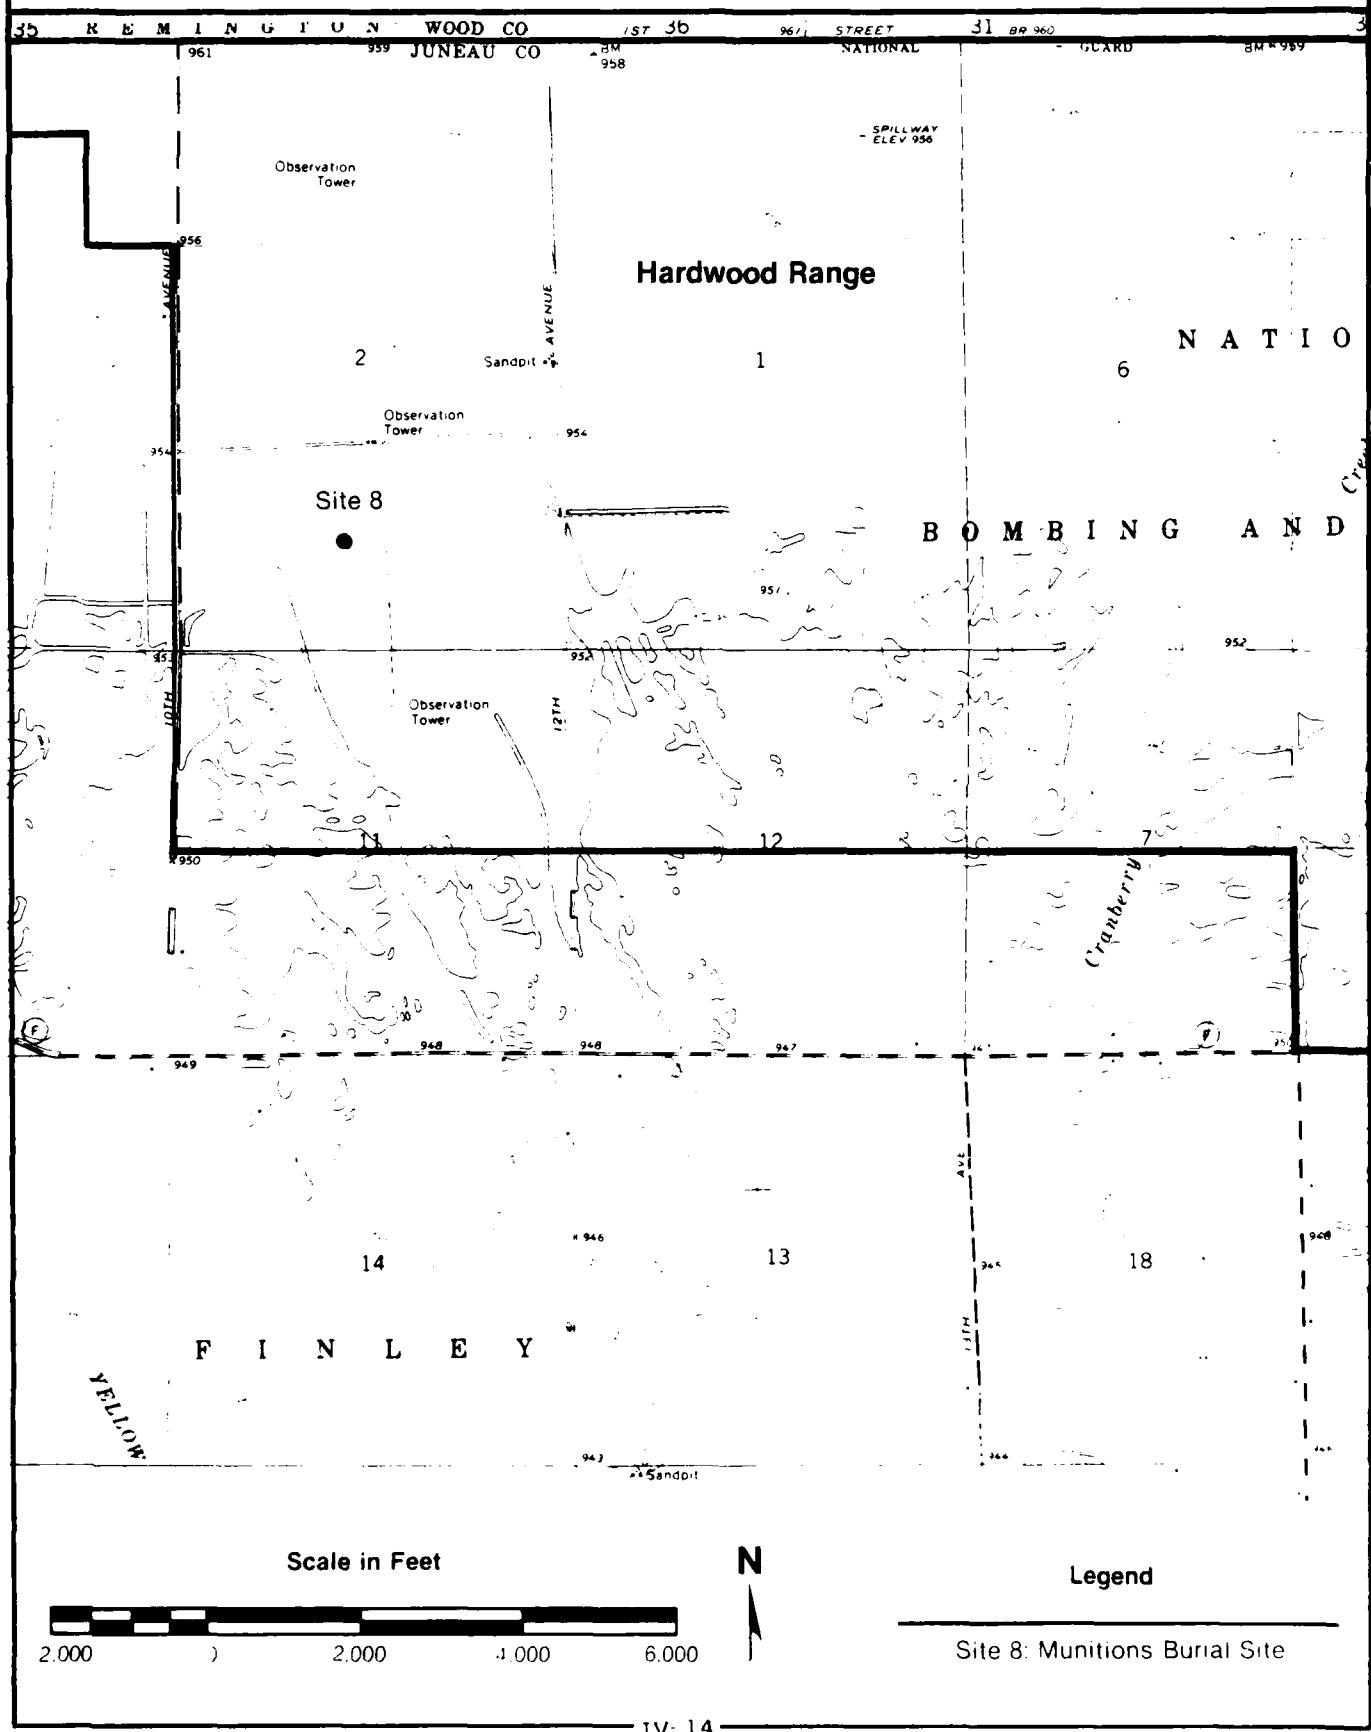
Figure 15b.

**Location of the Rated Waste Disposal Site
at Hardwood Range.**
